(NASA-CR-183585) SPACE STATION PROTECTIVE
COATING DEVELOPMENT Final Report (Boeing
Aerospace Co.) 304 p CSCL 22B

SPACE STATION PROTECTIVE COATING DEVELOPMENT

Final Report

**Contract NAS8-36586
January 1989**

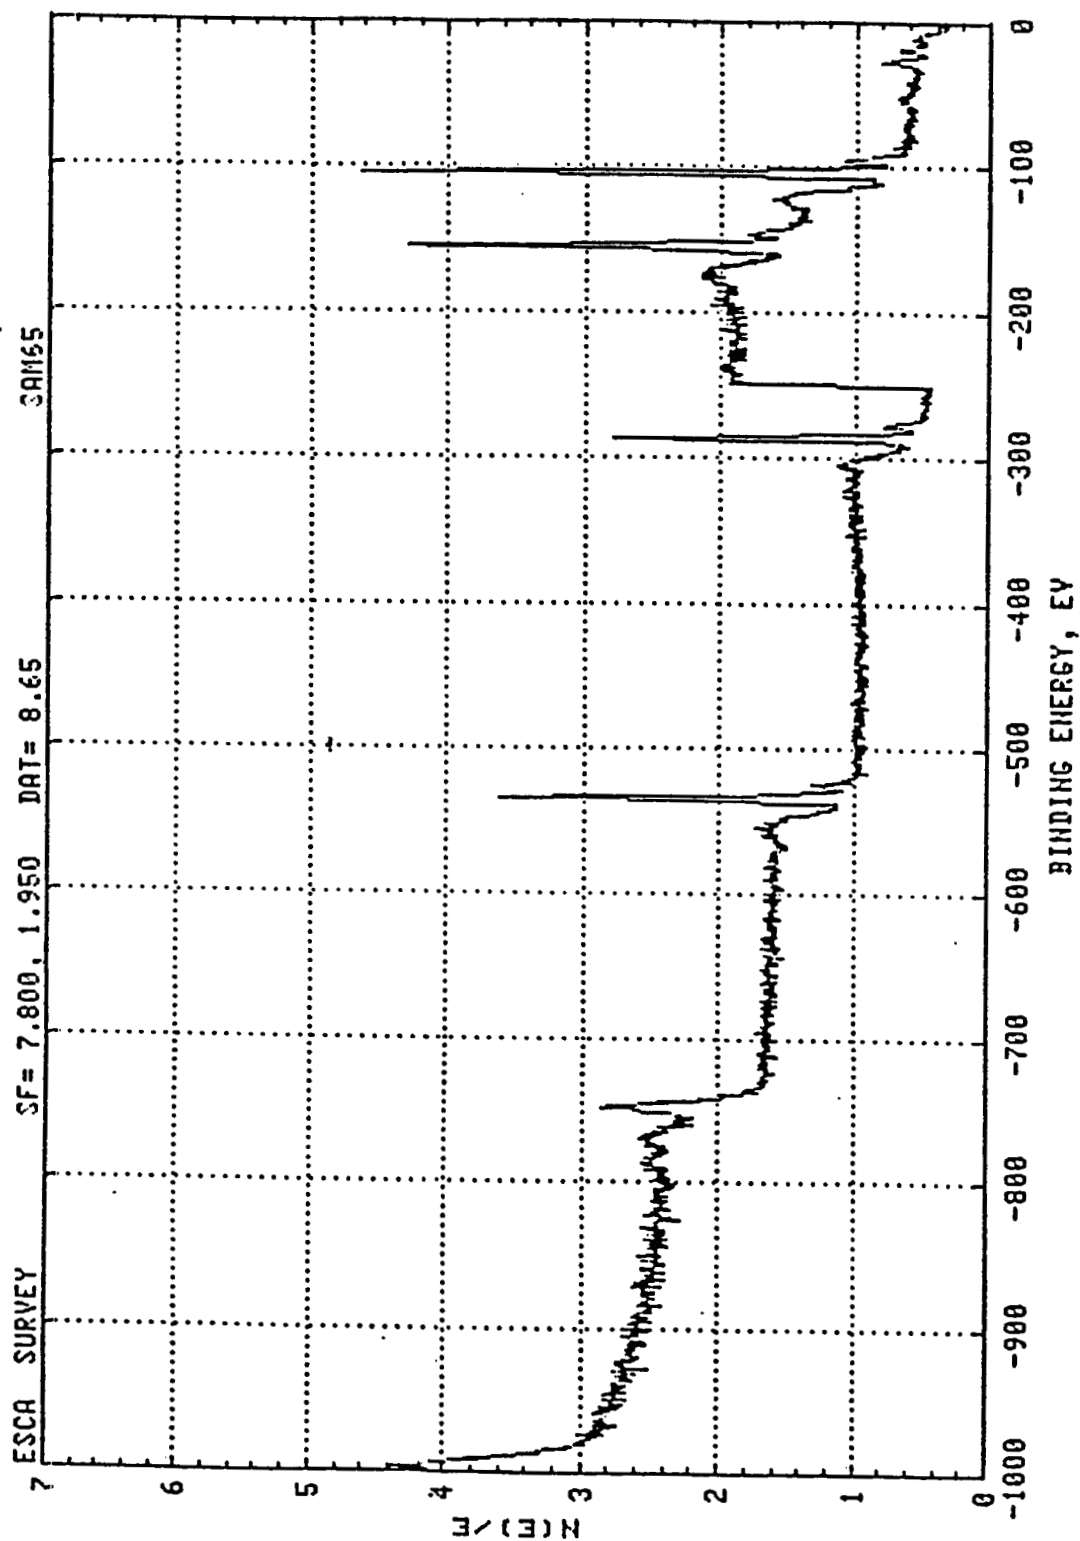
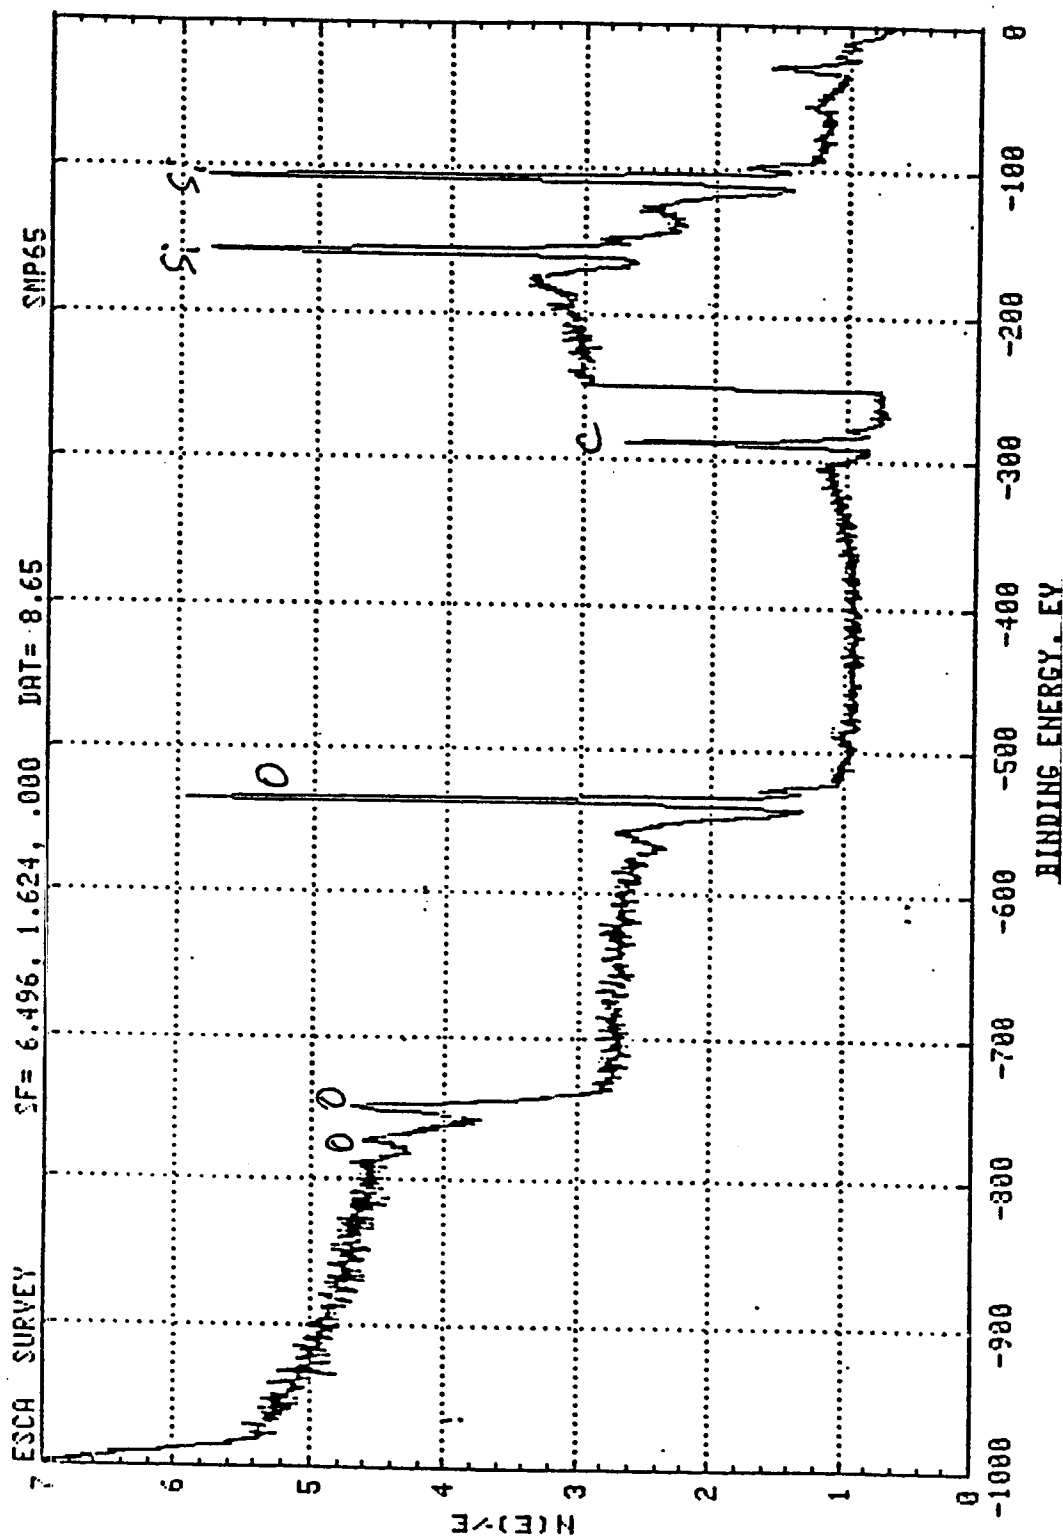
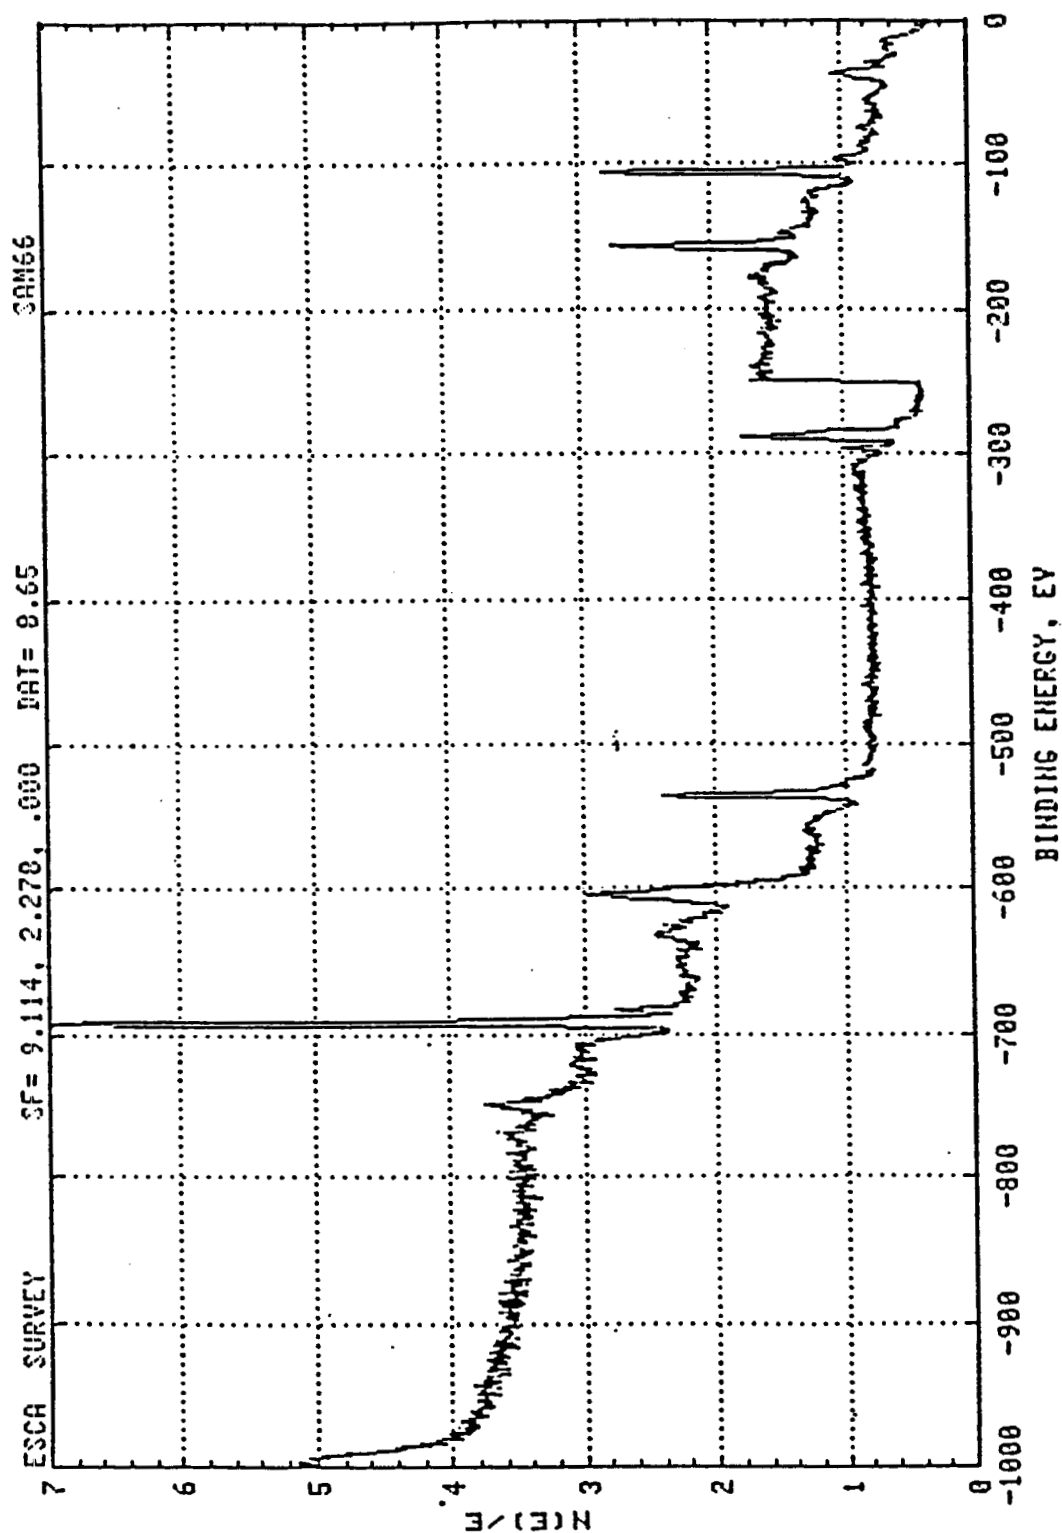
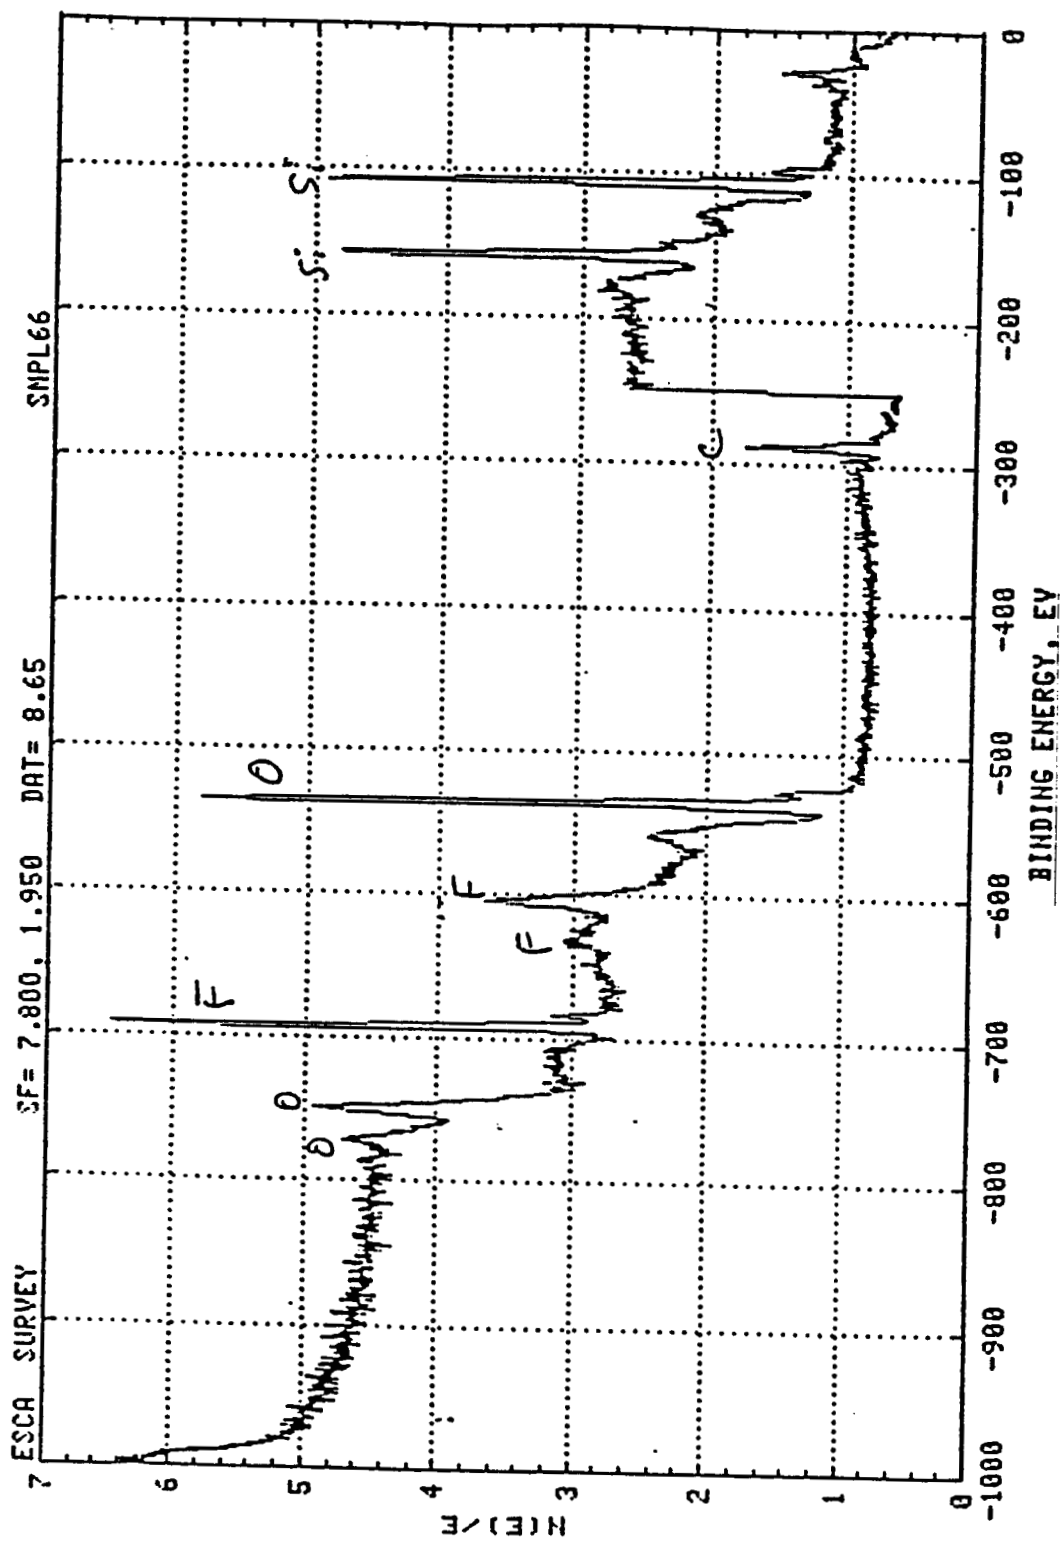
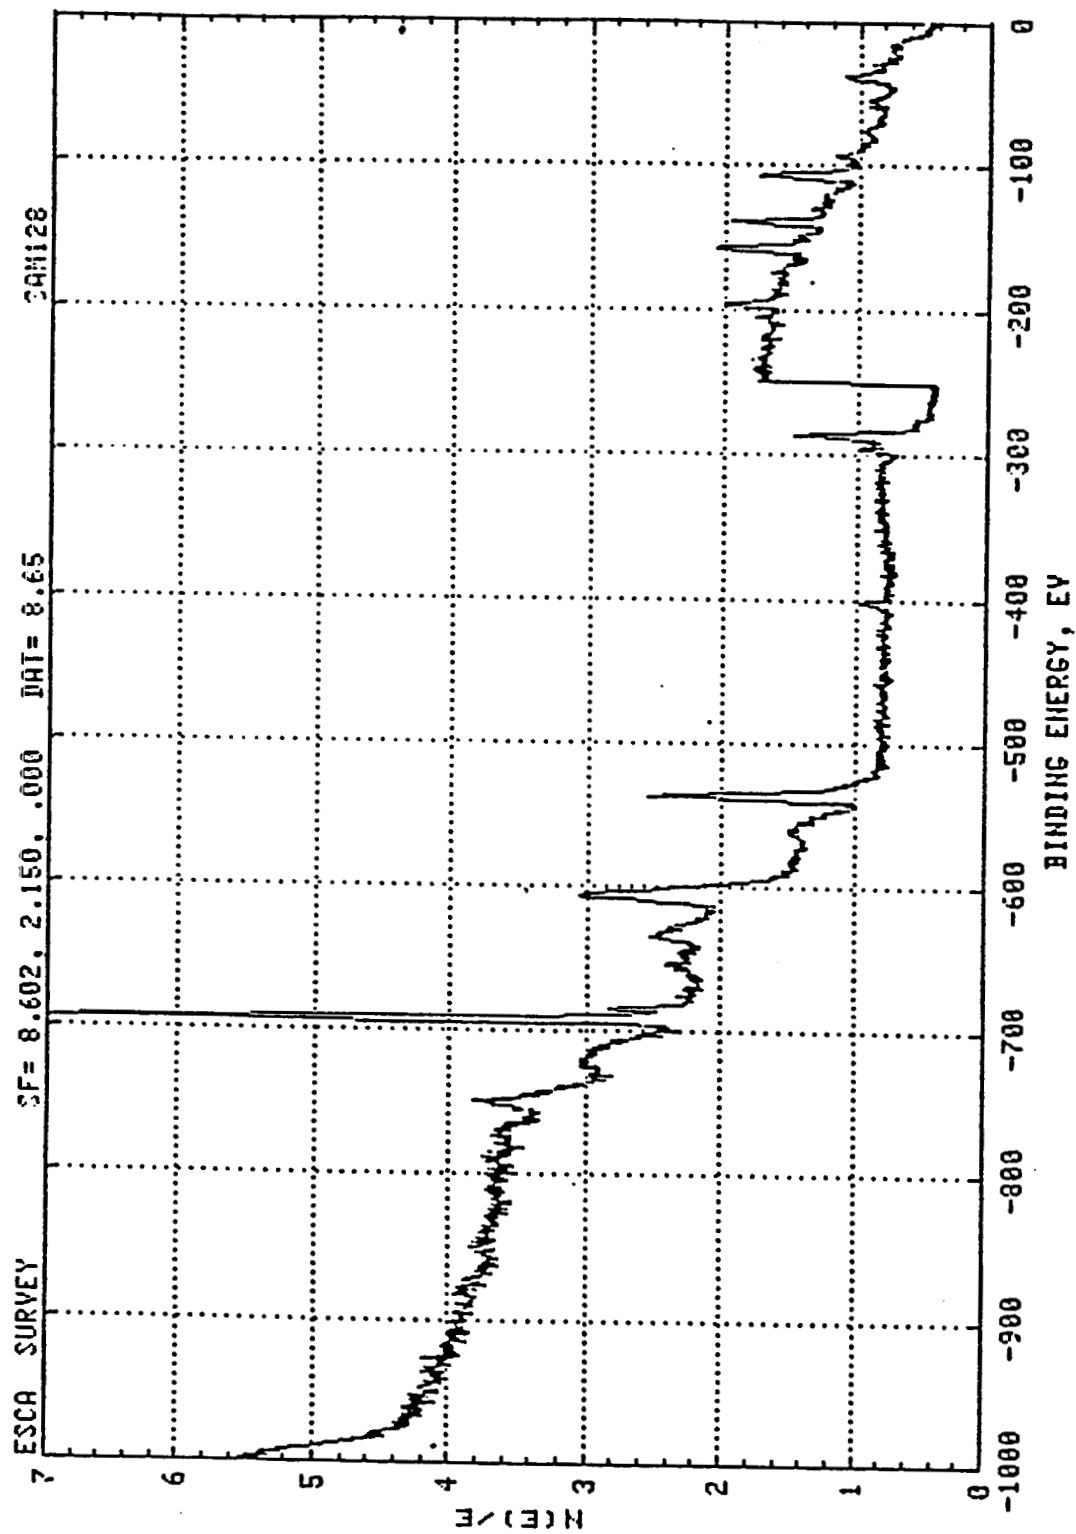
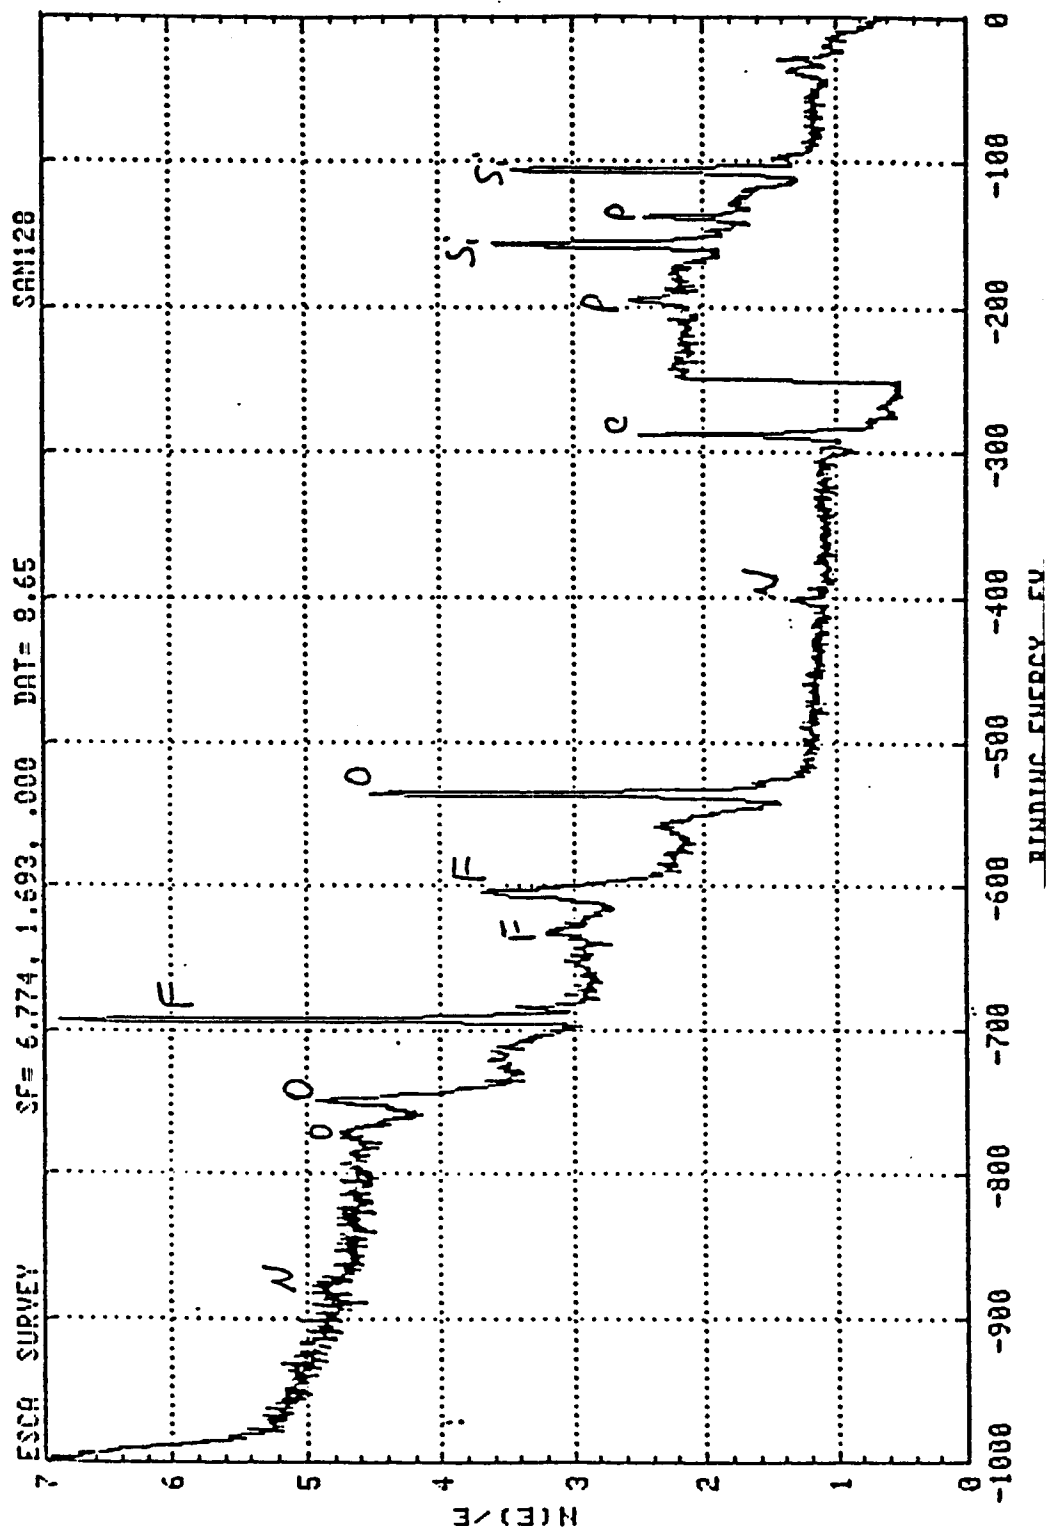
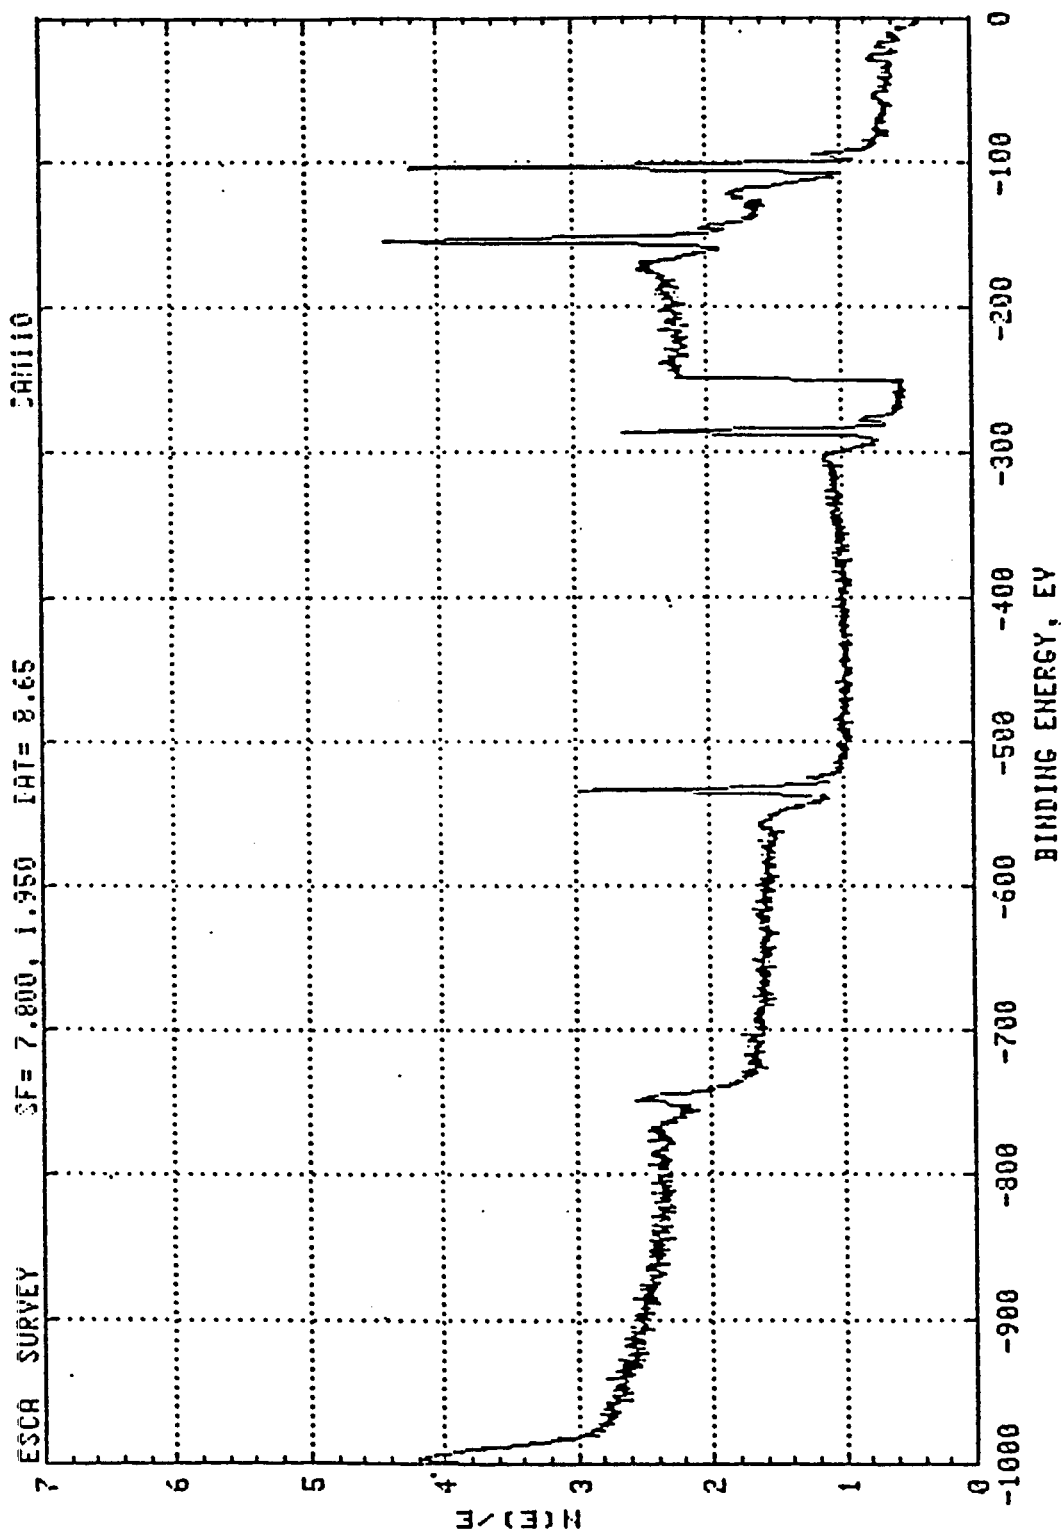
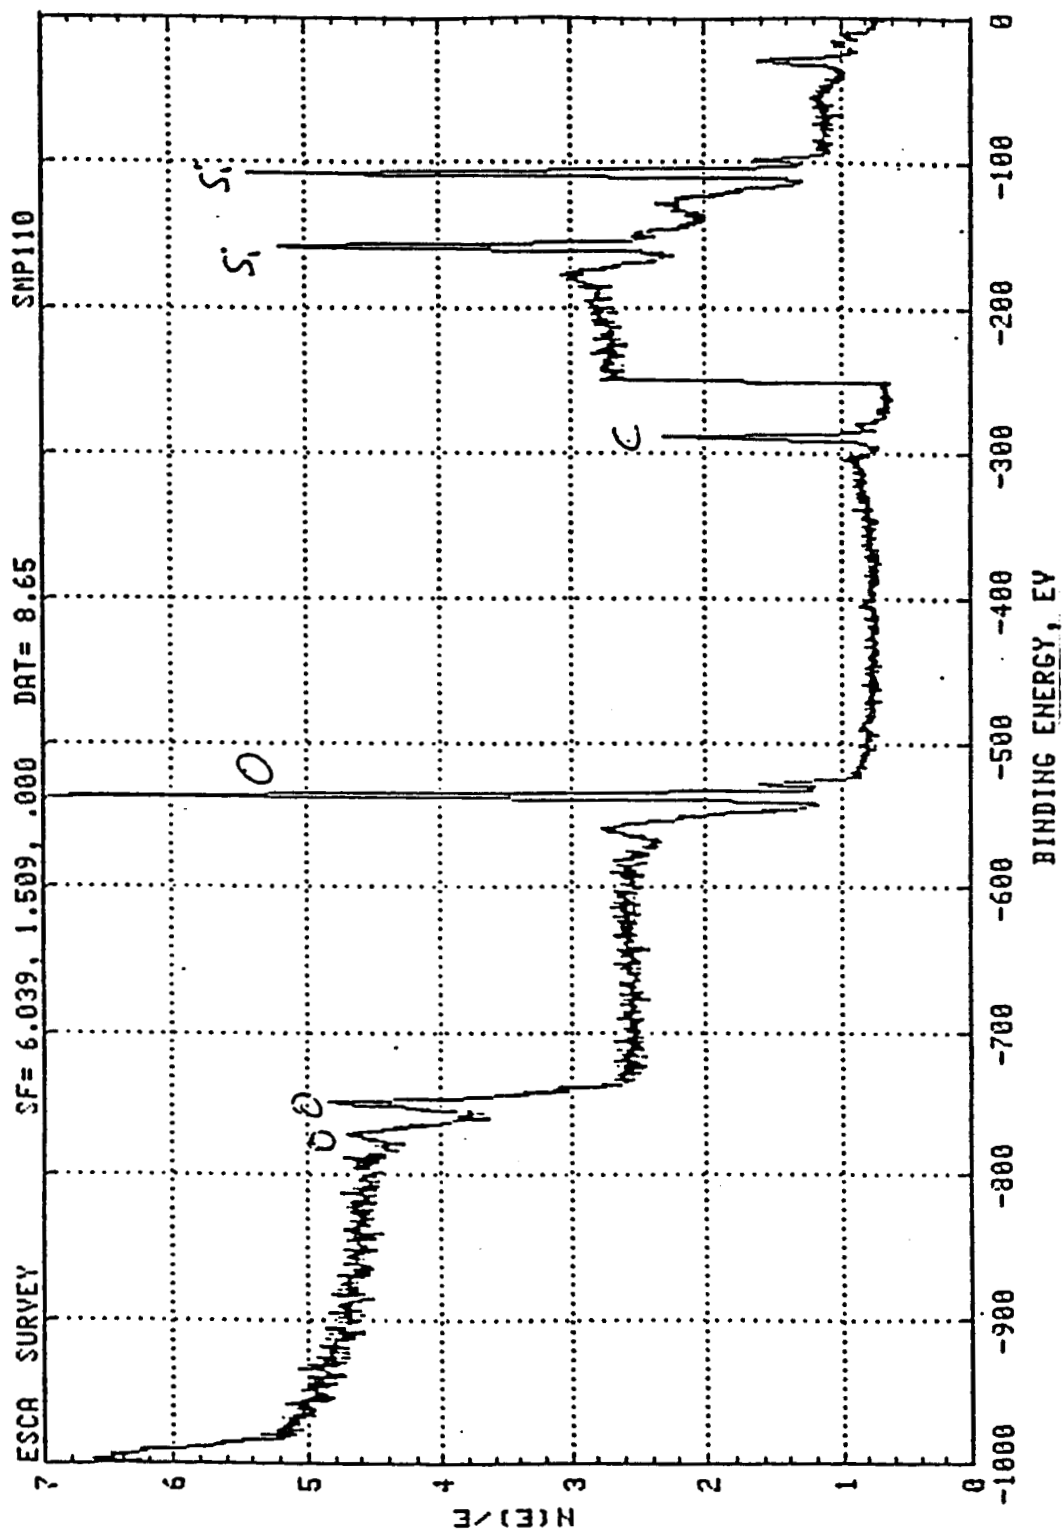
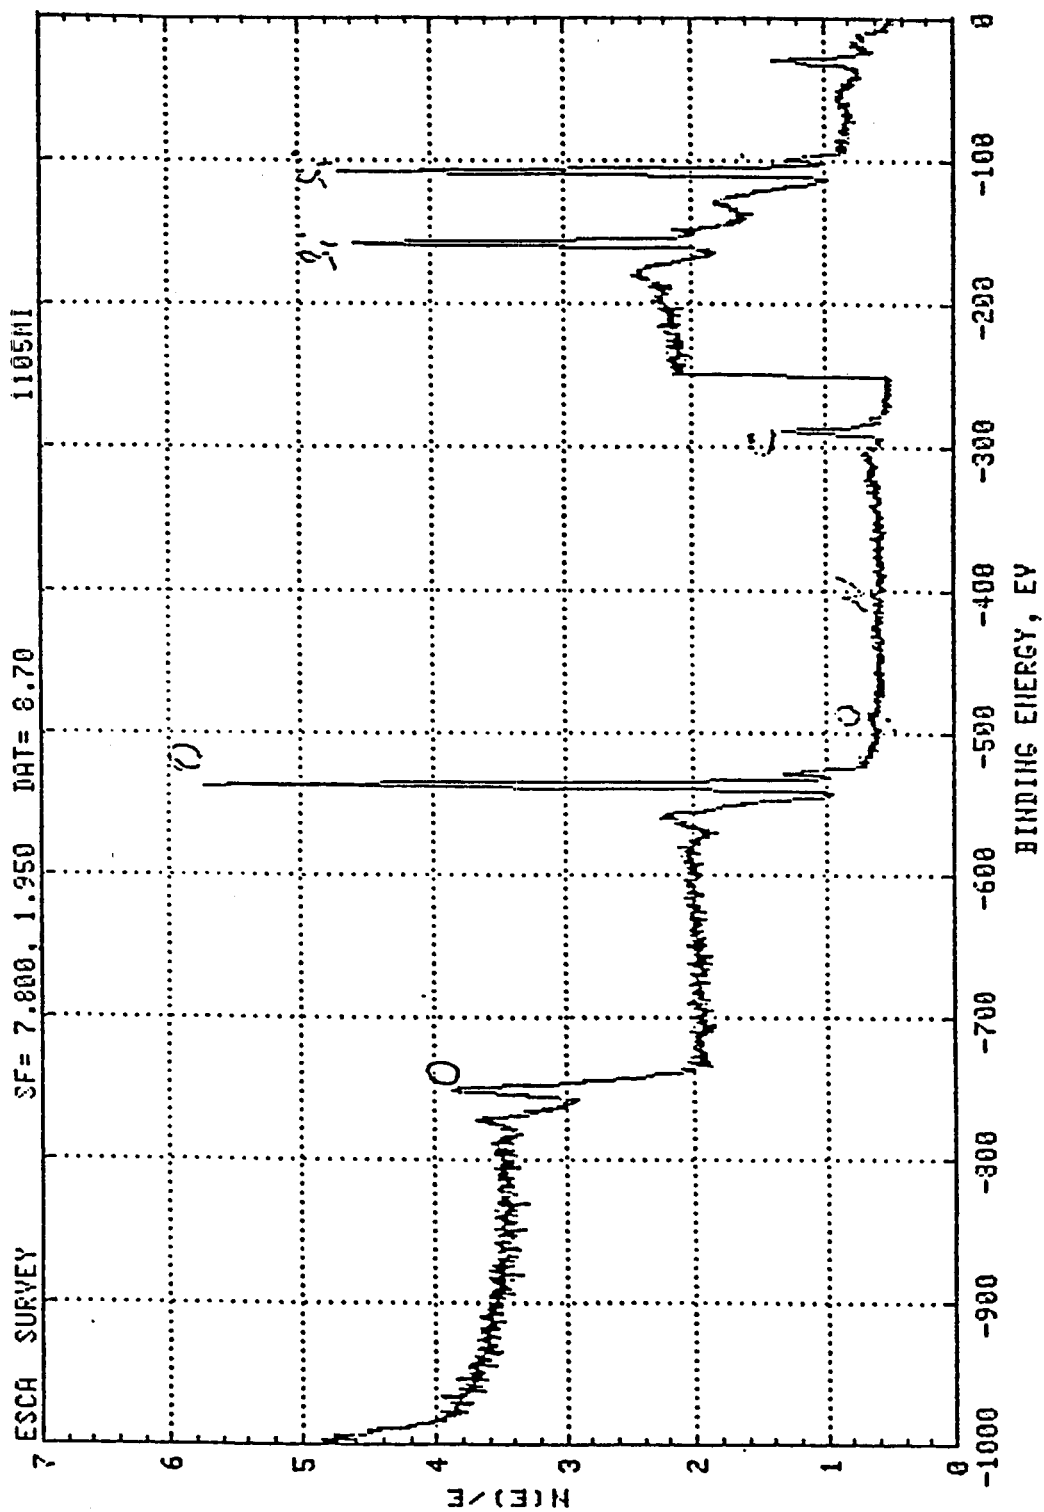
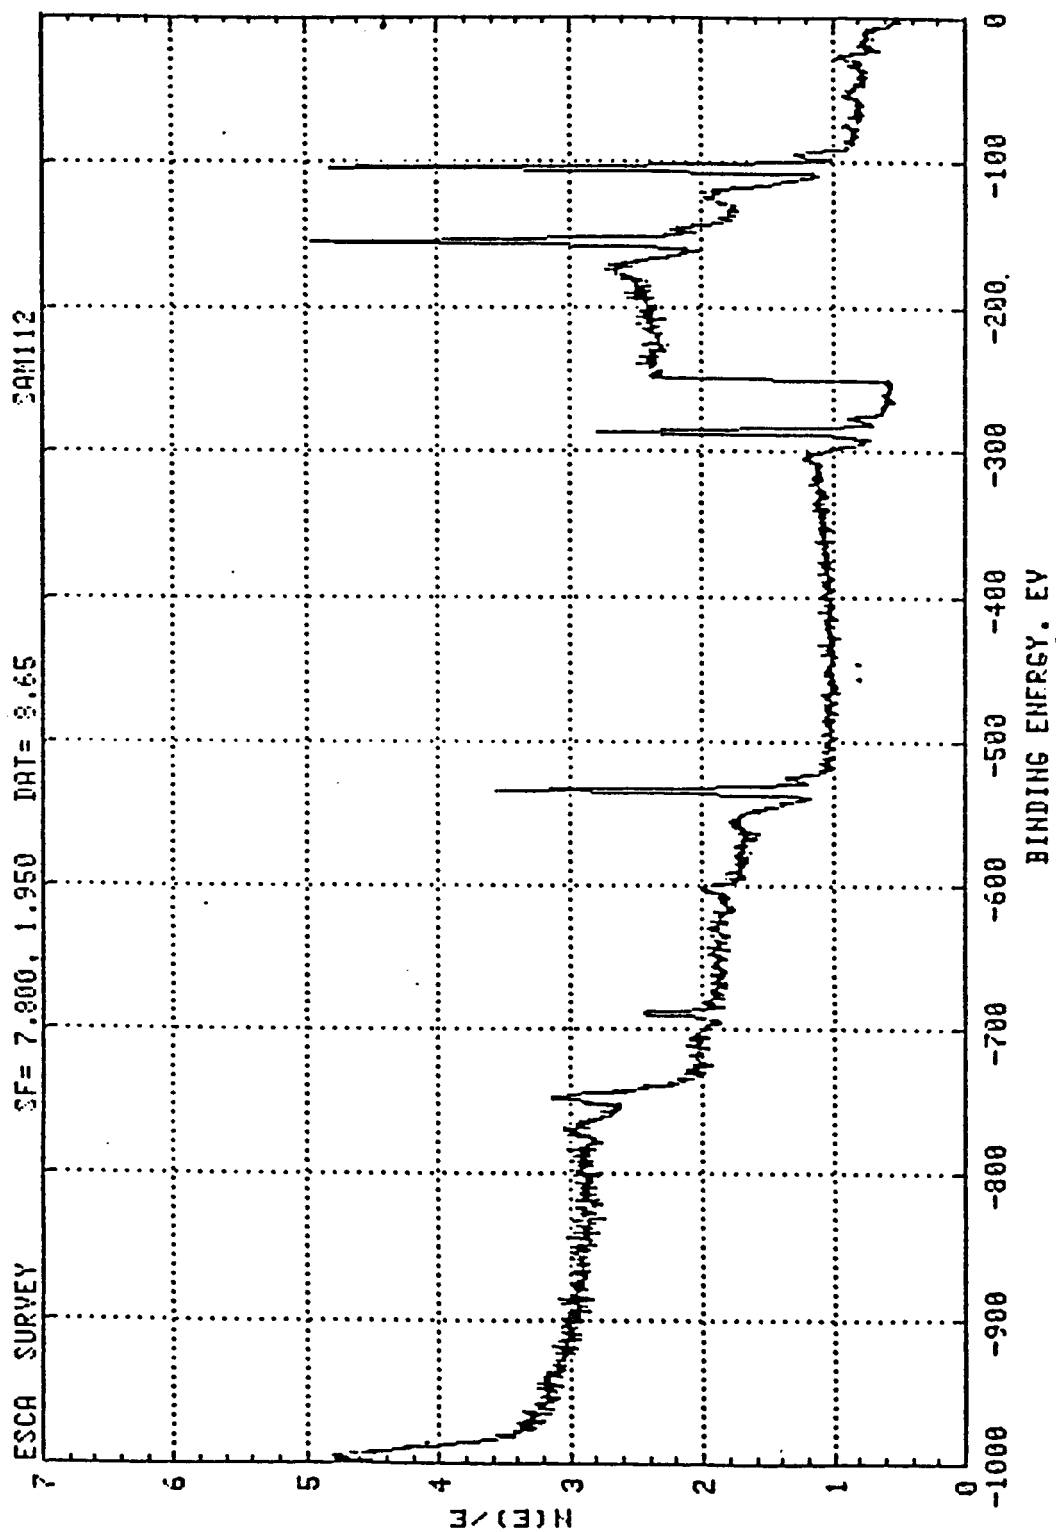
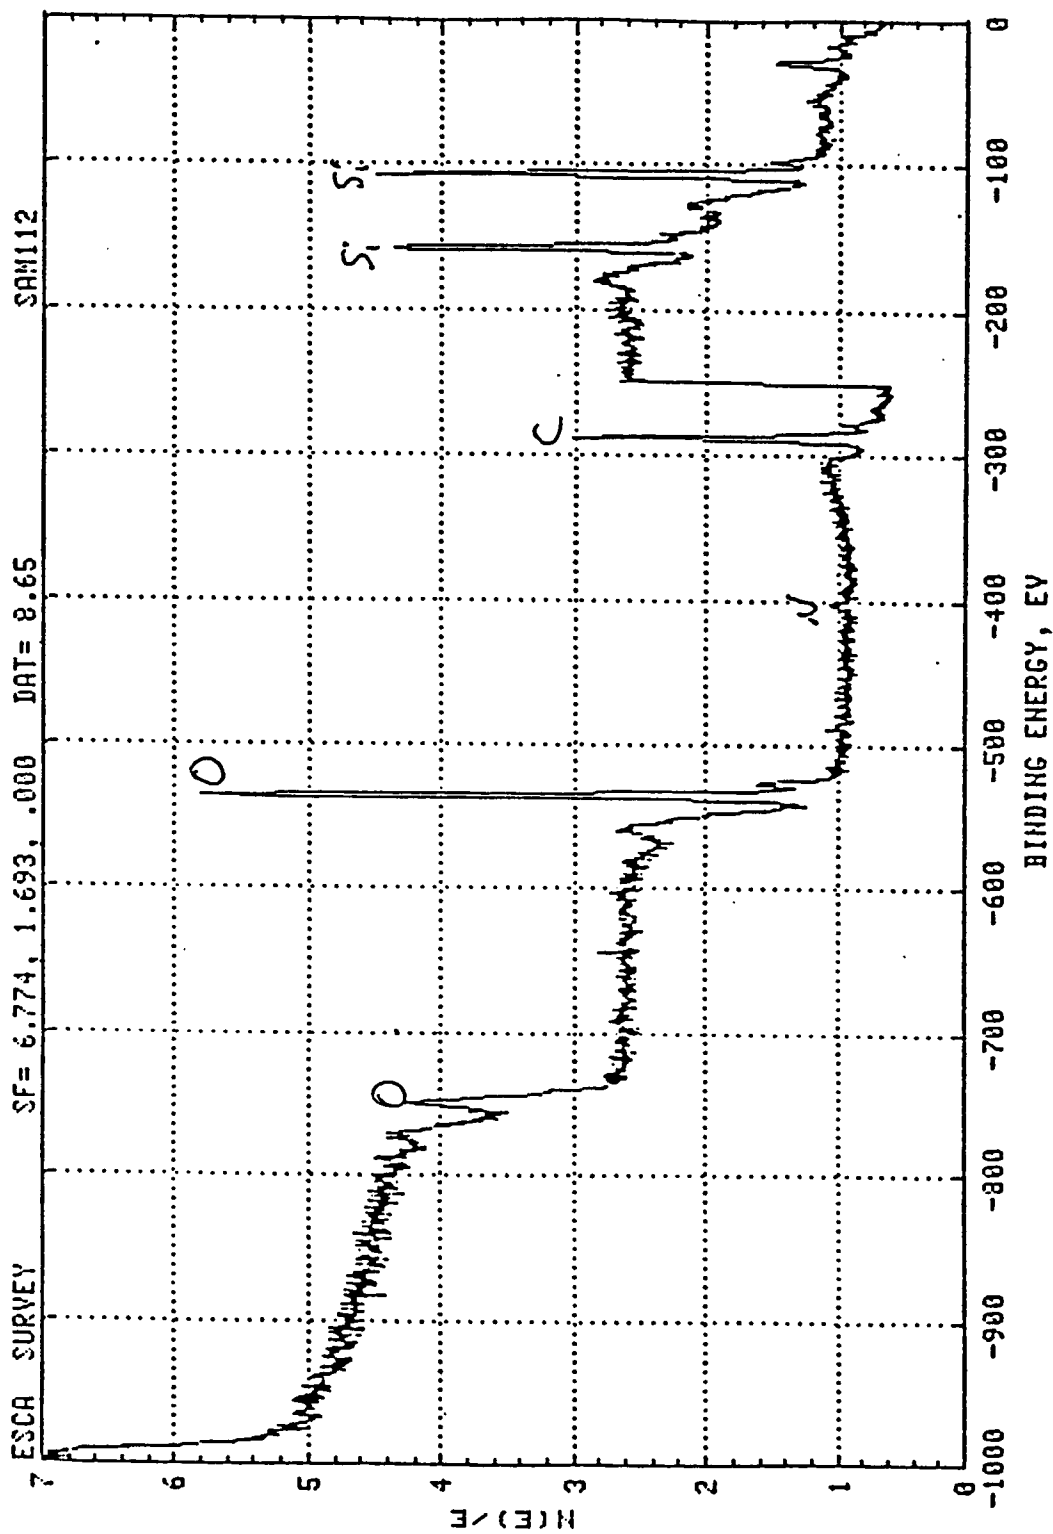
X-Ray photoelectron spectroscopy is used to identify elements and provides a measurement of their relative abundance on the surface of a material to a depth of about 40 angstroms. Tables 35 and 36 show the relative abundance of species on coated surfaces after each particular exposure to atomic oxygen. Figures 131 through 143 show the spectra from which the surface composition data were obtained.

Table 38 shows results of XPS analysis of the materials whose XPS spectra are shown in figures 131 through 143.

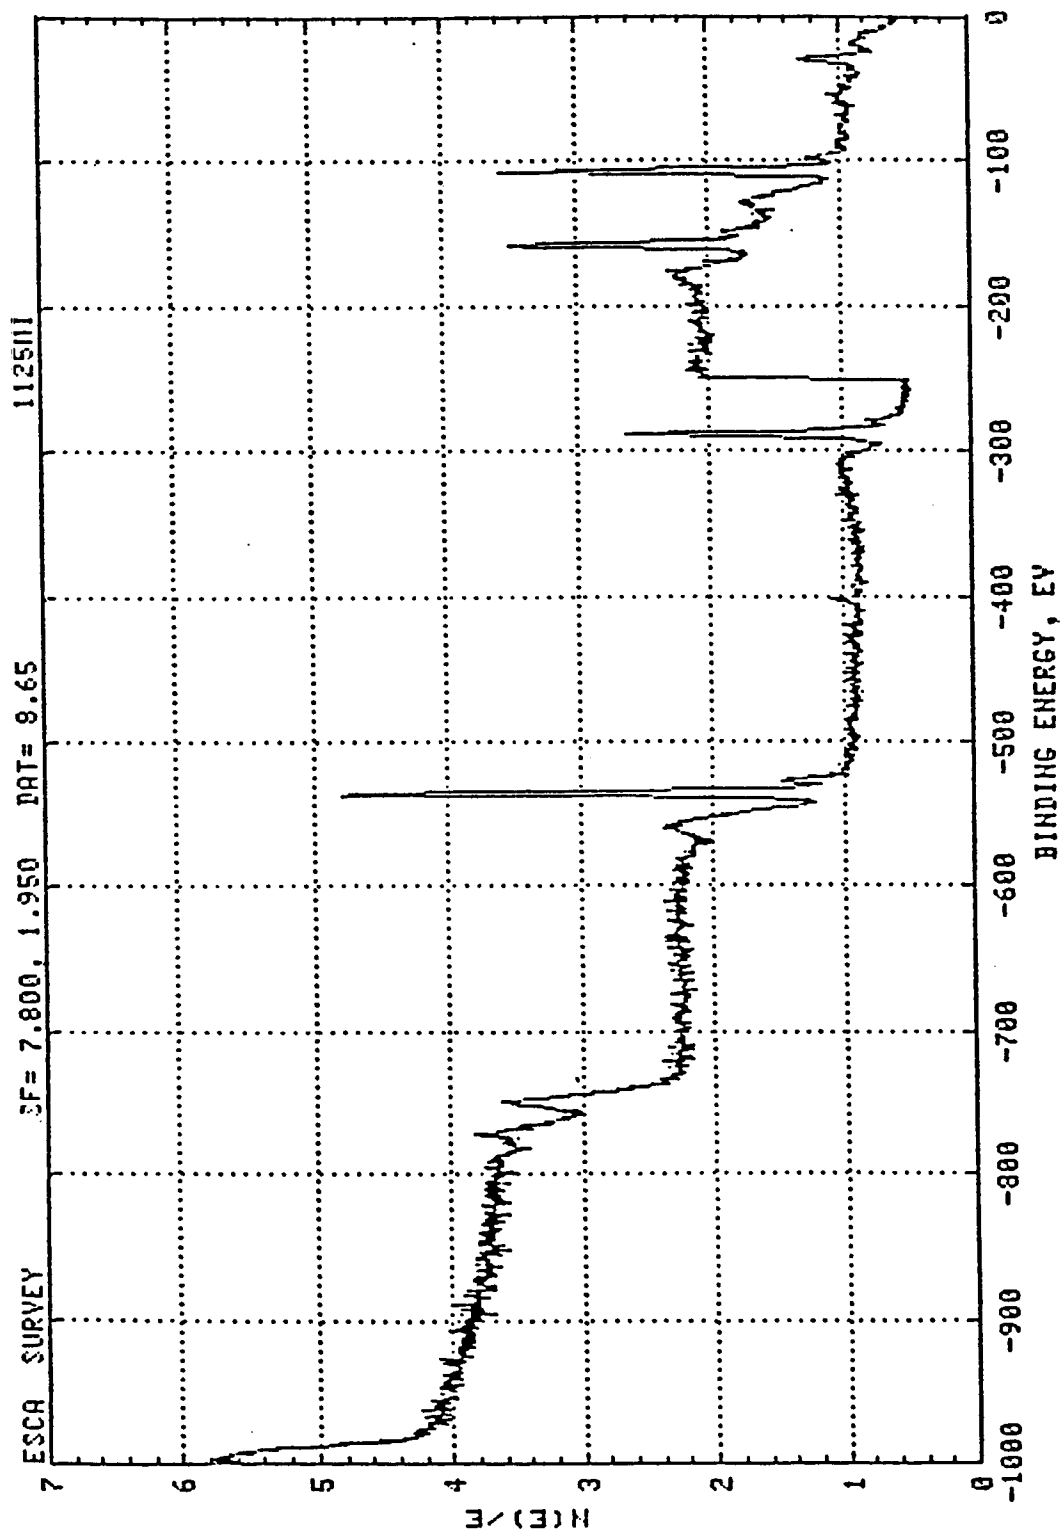
Figure 142: X-Ray Photoelectron Spectrum of Plasma Polymerized Hexamethyl-
disiloxane/Tetrafluorethylene Coating on Kapton. The Sample was
Previously Exposed to Atomic Oxygen for 95.75 Hours.

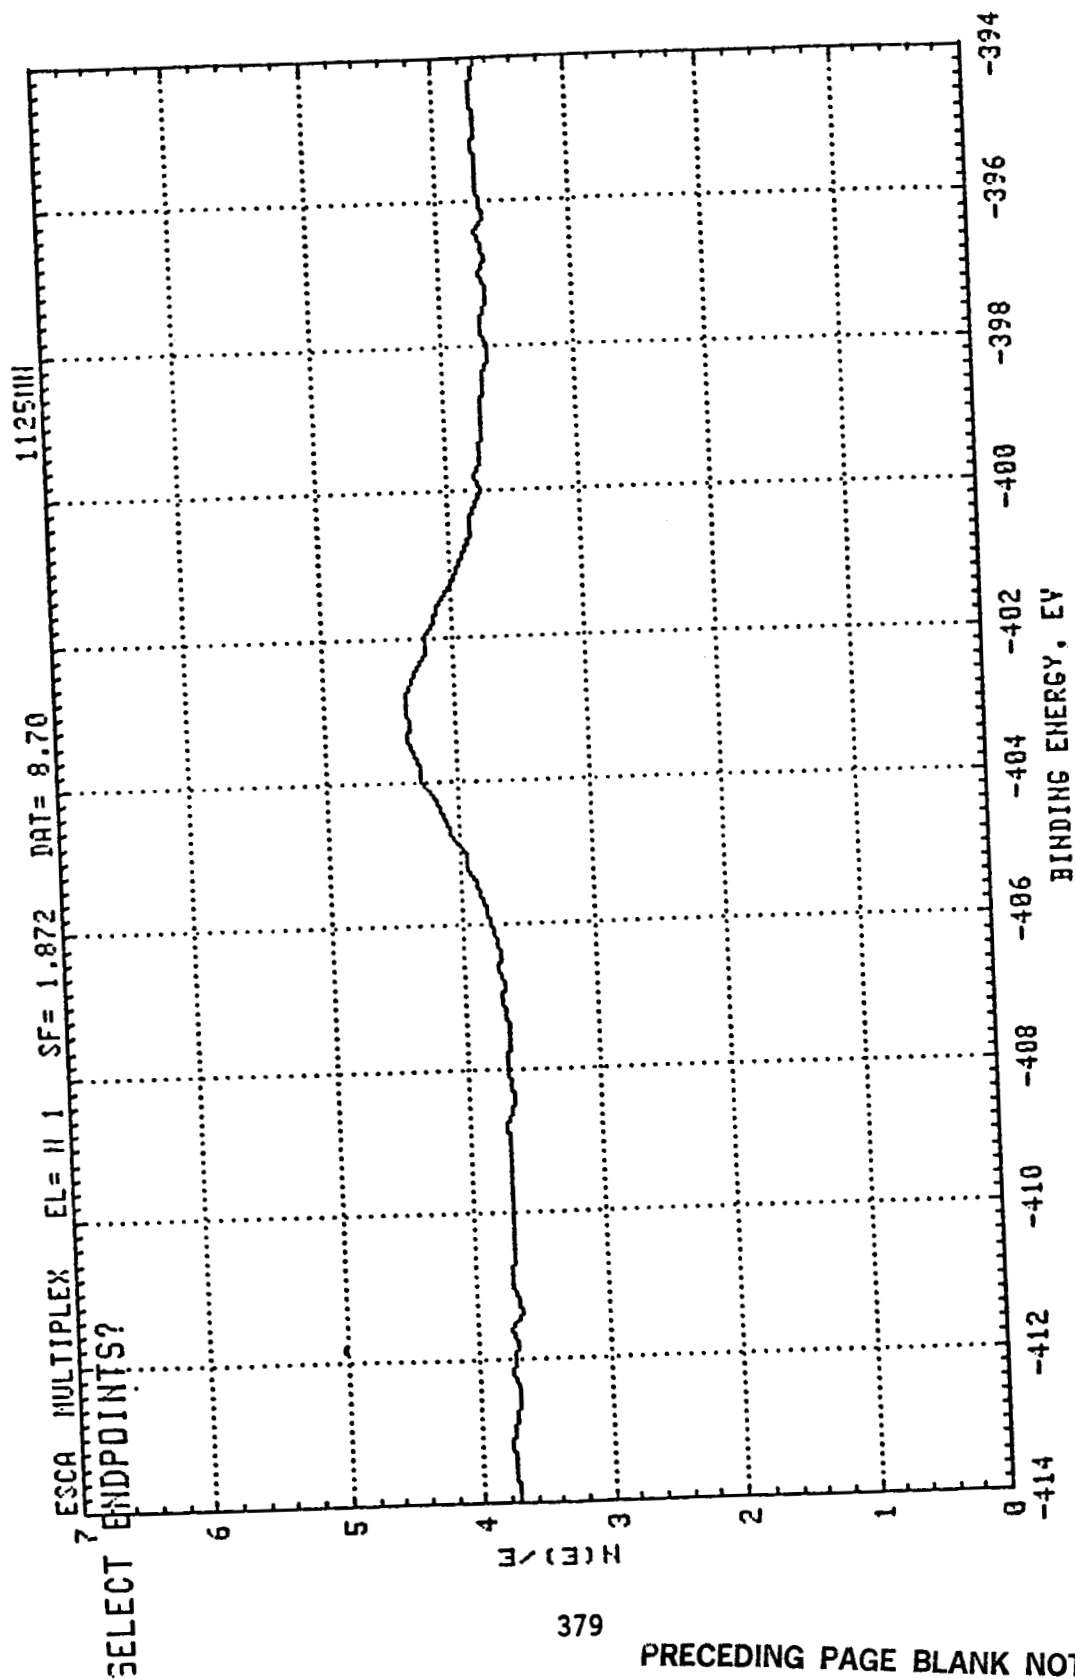
Figure 143: X-Ray Photoelectron Spectrum of Plasma Polymerized Hexamethyl-
disiloxane/Tetrafluoroethylene Coating on Kapton. This Spectrum
is an Expansion of the Region Around the Nitrogen Peak in the
Spectrum From Figure 142.
